Tail Light Repair

Recently while removing one of the tail light lens' on my 5th wheel to replace a burned out lamp, one of the tabs that holds the lens on broke off. My first reaction was now I have to buy a complete new light fixture. Upon a closer inspection I was able to repair the existing fixture and will never have to deal with the tabs breaking off again.

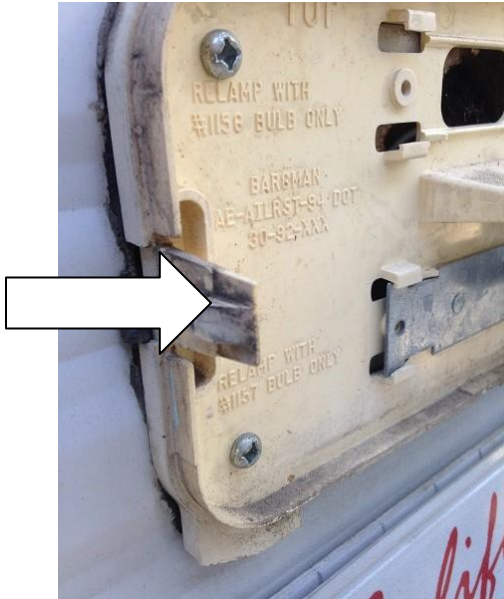
The tab on the left side was ok.

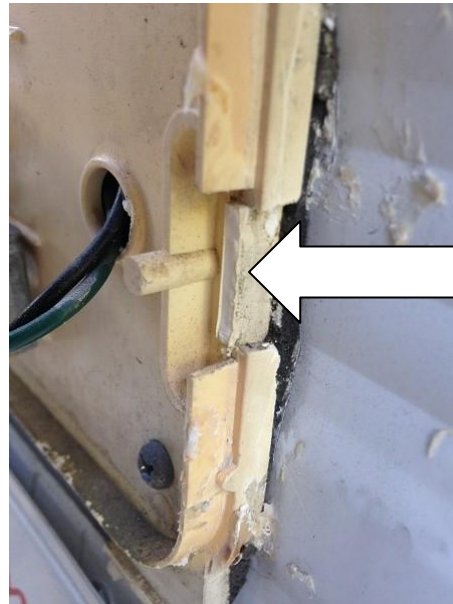
The brittle tab on the right side broke off.
